## TEM Analysis and Failure Mechanism Studies of Bromine-Induced Defects in Wafer Fabrication

### ABSTRACT

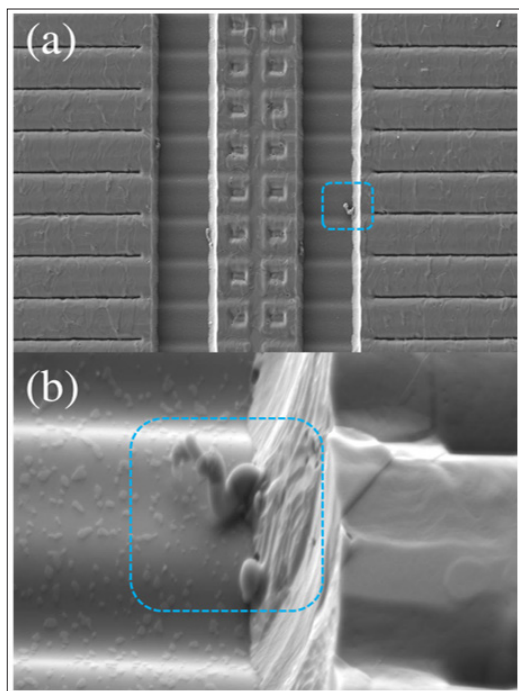
In the current study, the inline yield defect density reported that several lots of wafers were affected by a high-density of defects. Based on the map, the defects were present on Al metal lines. Inline SEM analysis showed that the defects existed mainly along the sidewall of Al metal lines, as shown in Figure 1 (a). High-magnification SEM analysis revealed that the defects were worm-like, likely growing from the sidewall of the Al metal, rather than from the surface of the Al surface, as shown in Figure 1 (b).

**Figure 1:** Low-magnification SEM image (a) and high-magnification SEM image (b) shows a worm-like defect in the sidewall of Al metal.

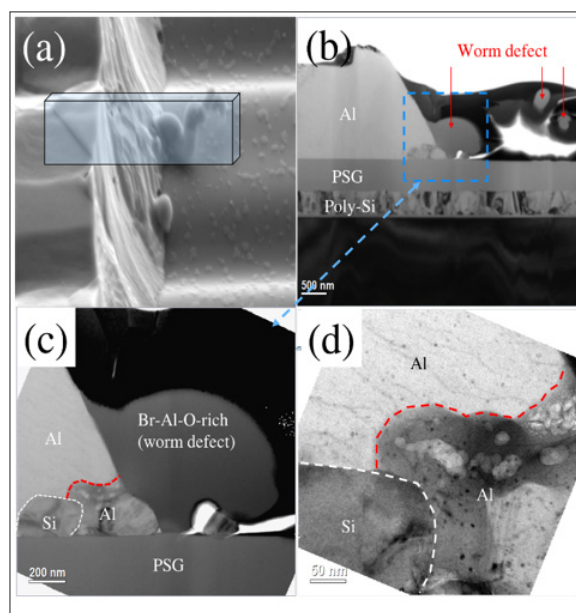
Figure 2 (b) show a low-magnification TEM image in the defect region. The defect was formed at the bottom corner of the Al metal with smooth surface. No direct root or structure correlation in between the worm-defect and Al metal, and Al sidewall next the defect was smooth. EDS micro-area analysis in Figure 3 indicated that the worm defect region was Br-rich (Point-1).

While in the bottom corner of the Al metal, a particle residue was observed, embedded in between Al metal and PSG (phosphor doped Si glass) layers, as shown by the TEM image in Figure 2 (c), and EDS analysis in Figure 4 and Figure 5 showed that the particulate defect was mainly Si-rich, tallying with the typical diffraction contrast of the polycrystalline structure observed under TEM (white dash line circled region, Figure 2 (c)). The Si-rich particle defect should be introduced before Al metallization. With such residue particle embedded at the Al/PSG interface, it is highly possible that there exist interfacial voids or gap in Al/PSG interface, which may easily trap some chemical residue, like Br in this case, inducing the Al metal corrosion in the region. Therefore, this could be major process weakness leading to the Br-induced Al corrosion.

**Figure 2:** (a) cross-section FIB-TEM location (across the worm defect); (b) low-magnification TEM image of the worm-defect and its neighbouring structures; (c) high-magnification TEM image of the defect region, showing the presence of Si-rich residue in between Al and PSG layers, and (d) the high-magnification TEM image of the Si-rich residue particle and the abnormal contrast in Al metal next to the worm defect, possible the growth origin of the worm defect.

Further zoom-in TEM analysis indicated the presence of voiding-like structure with non-uniform contrast in the Al metal next to the worm defect, as shown by the TEM image in Figure 2 (d) (red dash line circled region). Such abnormal contrast might be the signature related to the Al metal corrosion although EDS analysis did not show appreciable Br in this region. It is possible that Al corrosion started in this corner region with the Si residue defect and Br trapping. This led to the continuous chemical corrosion process, and final formation of the worm defect in the corner sidewall region.

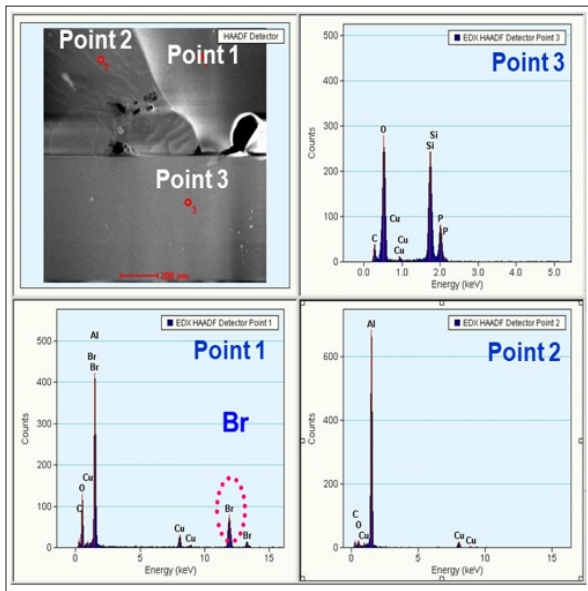
Figure 3: EDS micro-area analysis in the worm defect region

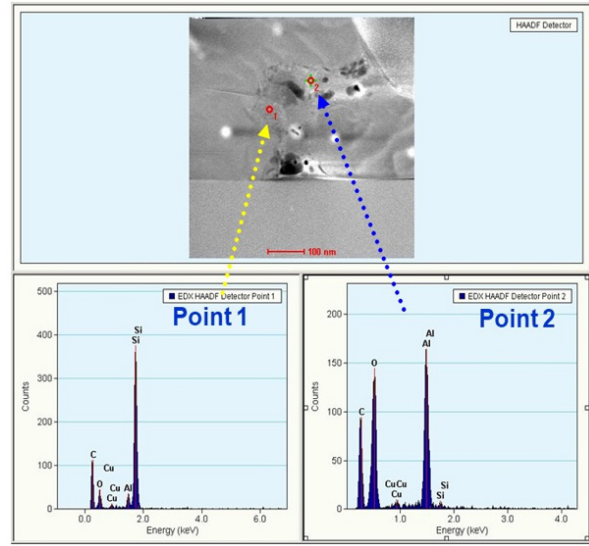
Figure 4: EDS micro-area analysis in the particle residue region (next to the worm defect)

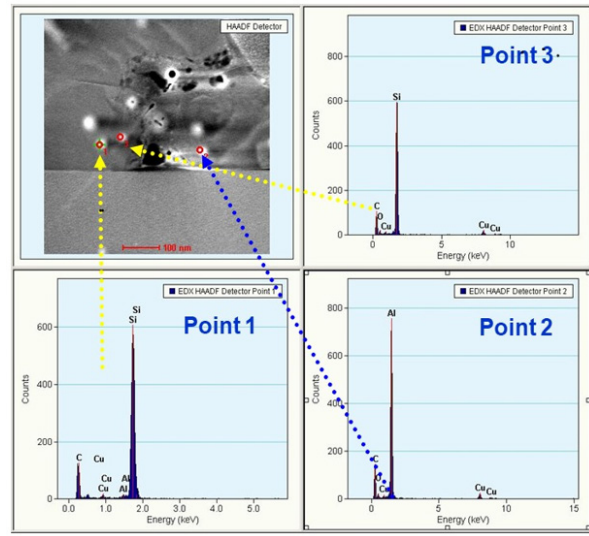
Figure 5: EDS micro-area analysis in the particle residue region (next to the worm defect).
