**Case Report**
**Open Access**

## Iatrogenic Root Perforations: Case Report

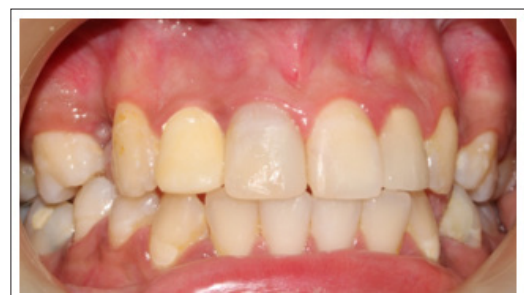
**Figure 1:** Intraoral Photographs of the Initial Clinical Situation

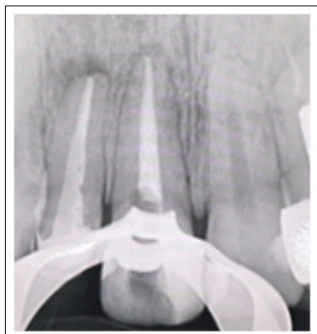
Figure 2: Pre-Operative Radiography

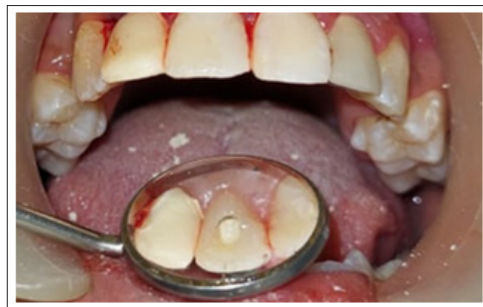
Figure 6: Sealing of the Perforation using HCS Material (Biodentine®)

guided tissue regeneration. Regarding obturation materials, we had the option of using either MTA or Biodentine®; nonetheless, we chose the latter to prevent future discolorations.

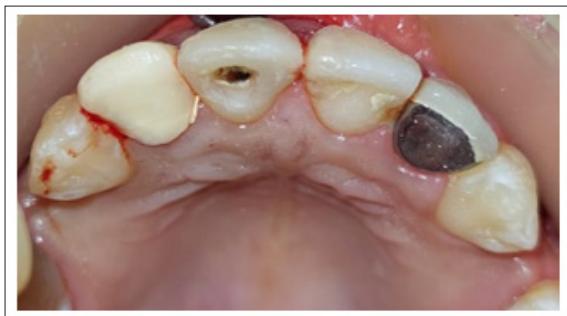
Figure 3: Intraoral Palatal View of the Initial Clinical Situation

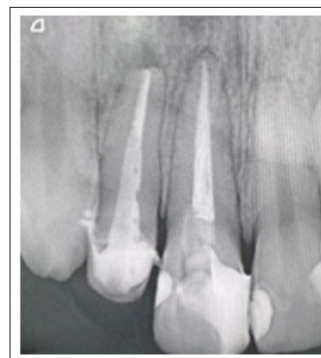
Figure 7: Follow up after 3 months with Proper Coronal Obturation

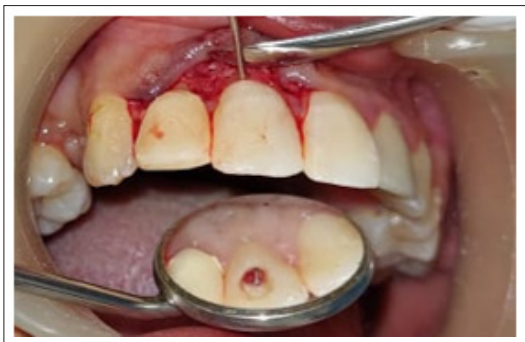
Figure 4: Intrasulcular Incision was applied and a Flap was raised and the Infra-Osseous Perforation was Located

Initially, we started with the realization of an intrasulcular incision without relieving incisions, then a flap was raised and we located the infra-osseous perforation. Following that, we cleaned the cavity and disinfected it with 2% chlorhexidine as final irrigation in the canal. Then the access cavity was revised and dried. Biodentine® was mixed and placed in the access cavity, which was carried out using an anterior Schilder plugger. Finally, the cavity had been properly sealed.

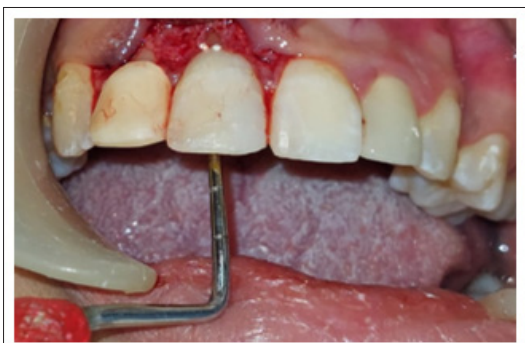
Figure 5: Placement of Biodentine® using an Anterior Schilder Plugger

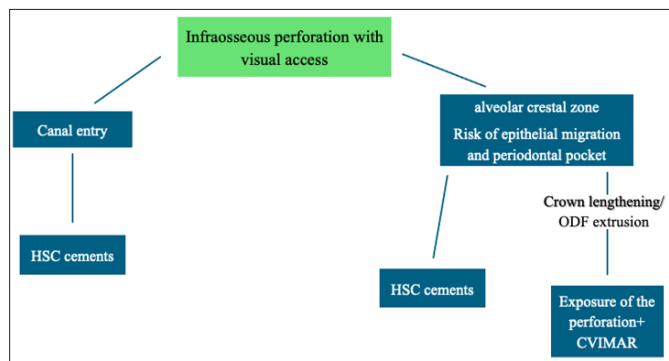
Figure 10: Therapeutic Decision Tree in the Case of an Infra-Osseous Perforation with Visual Access.

The clinical approach to a confirmed radicular perforation might be a non-surgical or a surgical treatment. In a systematic manner, non-surgical treatment will be initially preferred. Nevertheless, the surgical intervention may be considered if

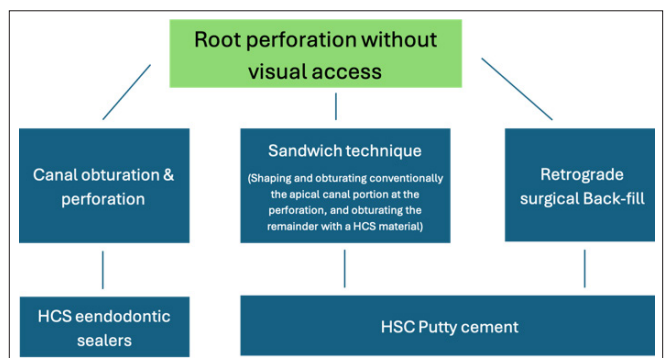
Figure 11: Therapeutic Decision Tree in the Case of an Infra-Osseous Perforation without Visual Access.

- The defect's shape or nature is unknown, or if it is sub-crestal and causes pathology or symptoms.
- Extensive intracoronary/extracoronary restoration blocks internal access.
- A large defect prevents material control.
- An apical third perforation with persistent disease is difficult to clean and repair.
- External cervical resorption cannot be repaired internally.
