## Asbestos Presence in 20<sup>th</sup> Century Buildings

Ruben Rodriguez Elizalde

**Keywords:** Asbestos, 20<sup>th</sup> Century Buildings, Inspection, Chrysotile, Deasbestos

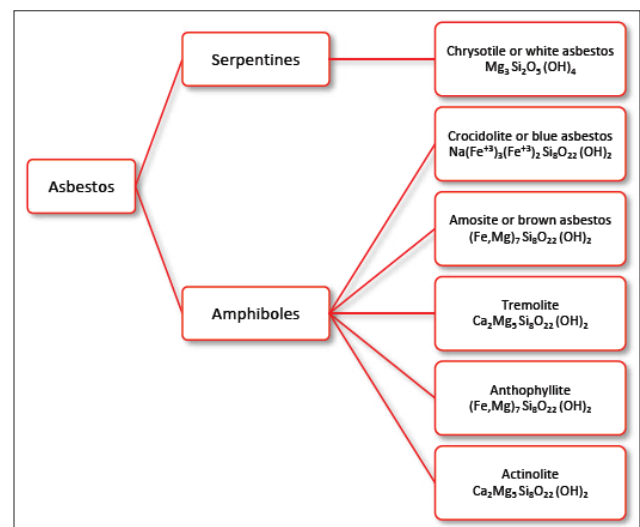
Figure 1: Classification Scheme of Asbestos Main Varieties [2].

Asbestos fibers are clasificated in two varieties groups: serpentine asbestos and amphibole asbestos [2] (Figure 1).

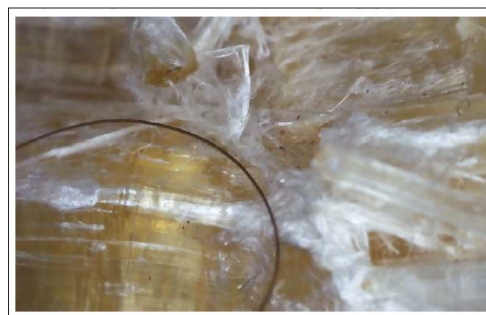
**Figure 5:** Chrysotile Fiber Group (Thousands of Tiny Fibers Packed Together) from Figure 4, 50X Compared to a Male Eyelash (author's Photograph)

In its natural state, chrysotile crystalline structure has strata or layers (Figure 5, Figure 7 and Figure 8), which can form small fibers with diameters between 0.02 and 0.03  $\mu\text{m}$ , and can reach length-diameter ratios around 100/1 [3,7]. Figure 5 shows us size comparison between a chrysotile fibers bundle (Figure 4), also formed by thousands of small fibers as well, and a male eyelash.

We have said that fibers are microscopic too (Figure 5, Figure 7, Figure 8 and Figure 13). The danger of asbestos are those fibers. These microscopic fibers are suspended in the air and, when a person inhales them, the fibers are not retained by any respiratory system defense mechanism. This is different from other bigger pollutants particles. For this reason, asbestos fibers can travel through the respiratory passages until reach the lungs, and lodge in them for a long time. So, fibers can be ingested and cause disease.

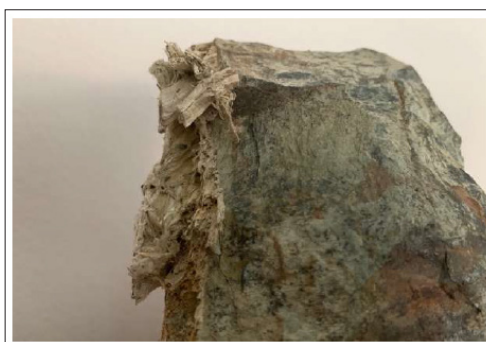
**Figure 6:** Mineral Chrysotile Sample on Matrix from Sierra Nevada, Spain (author's Photograph).

There are three polymorphic forms that crystallize in the monoclinic system. However, here we are interested in the fibrous polymorphic form, known as chrysotile or more commonly "white asbestos" (Figure 4 and Figure 6).

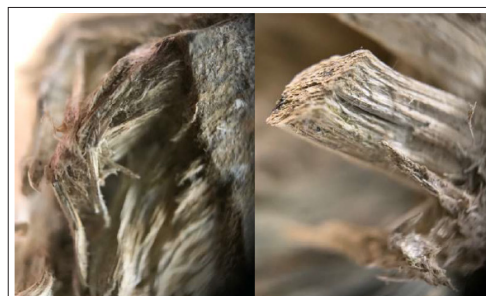
**Figure 7:** Chrysotile Fibers from Figure 6, 50X (author's Photograph)

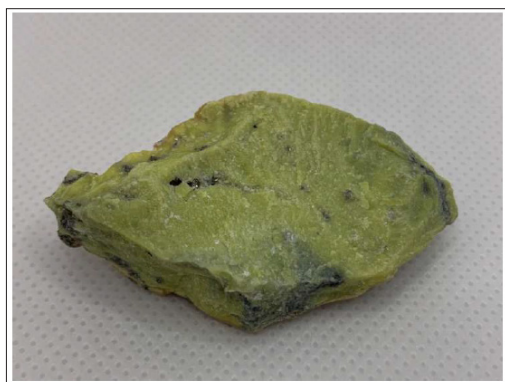
**Figure 9:** Mineral Serpentine from Madagascar (author’s Photograph).

Serpentine appears disseminated in igneous rocks and in metamorphic rocks. In the Figure 9 we can see a sample from the extensive areas of regional metamorphism of Madagascar: accumulations of very fine grain, whose color varies between light green and yellowish green. For the purposes of this paper, the sample is interesting for the bright veinlets of chrysotile that can we discover on it. (Figure 10).

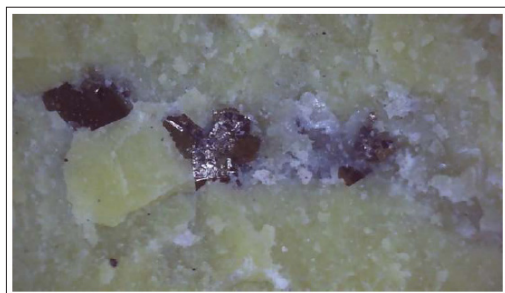
**Figure 10:** Veinlets of Chrysotile over the Figure 9 Sample Mineral, 25X (author’s Photograph)

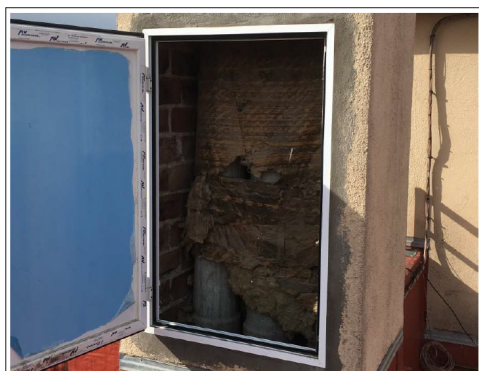
**Figure 18:** Fiber Cement Chimney Ducts, Protected with Asbestos Sheets for Thermal Insulation, in a Residential Building in Madrid, Spain (author's Photograph).

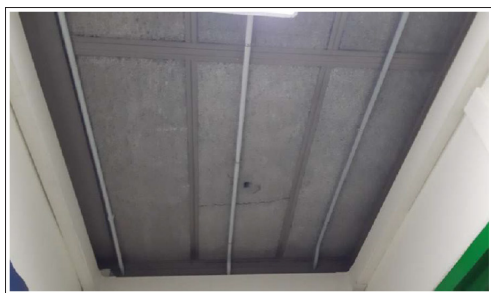
**Figure 19:** False Ceiling Plate with Asbestos-reinforced Material in a School (author's Photograph)

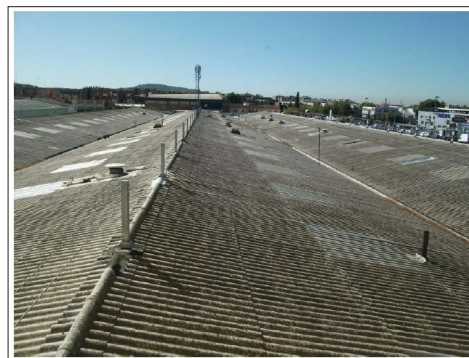
**Figure 20:** Corrugated Fiber-cement (Asbestos) Sheets Installed in 1970, Forming the Roof of an Industrial Building in Alcalá de Henares, Spain (author's Photograph).

- o Corrugated or flat plates for roofs and surface coverings (Figure 20). It is one of the uses of asbestos best known by people and, at the same time, most visible (Figure 21).
- o Windowsills and facade plates.
- o Interior partition plates and panels.
- o False ceilings.
- o Construction panels and shelves.
- o Chimney flues (Figure 18).
- o Pipes and channels for wastewater, downspouts, water tanks, water and gas channels or ornamental and gardening elements, etc.

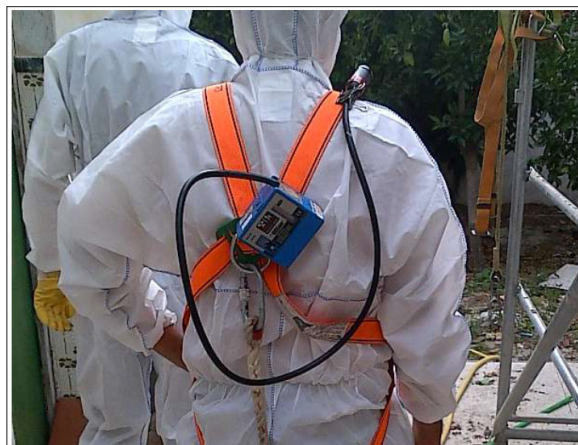
**Figure 22:** Personal Sampling Asbestos Fiber Content, with Equipment Arranged on a Worker in the Vicinity of an Industrial Building with Various Asbestos-Containing Elements (author's Photograph)

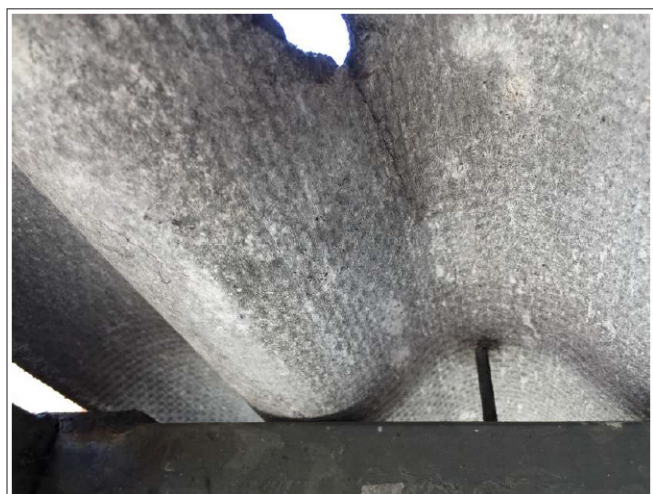
**Figure 23:** Fiber Cement Plate Fracture. Despite not being a friable material, the deterioration of this material implies the release of fibers and its consequent danger for people who are in the environment, so it is necessary to remove asbestos (author's Photograph)

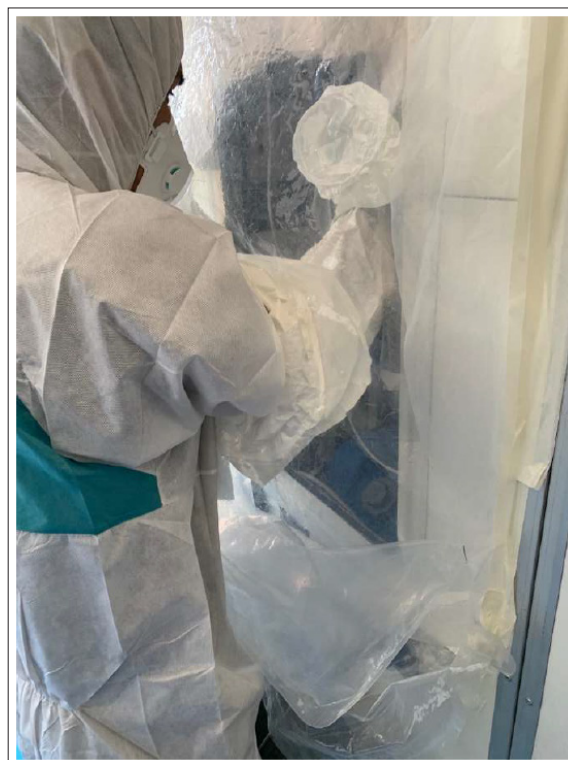
**Figure 25:** Encapsulation Simulation for a Possible Asbestos Element Recognition, in a Qualification Course for Future Building Inspectors and future Asbestos Removers (author's Photograph)

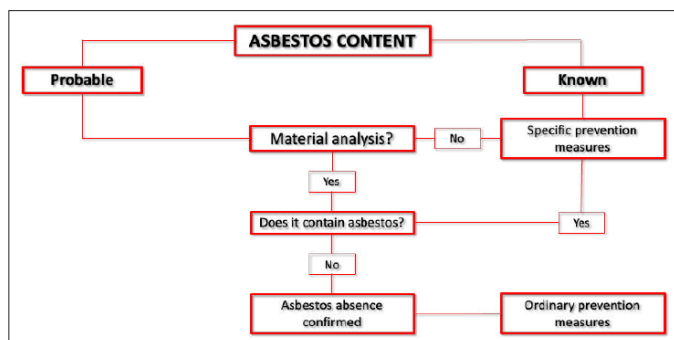
**Figure 26:** Alternatives and Decision Diagram on Asbestos Materials [13]

Obviously, everything changes depending on a possible diagnosis: the verification of the presence of asbestos through the analysis of the material will be what will mark the need for specific prevention measures or that ordinary prevention measures will suffice (Figure 26).

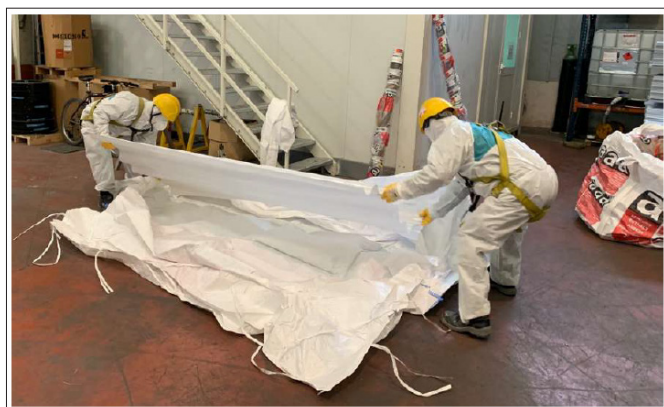
**Figure 27:** Asbestos Removal Simulation in a Qualification Course for Future Building Roof Removal Operators (author's Photograph)

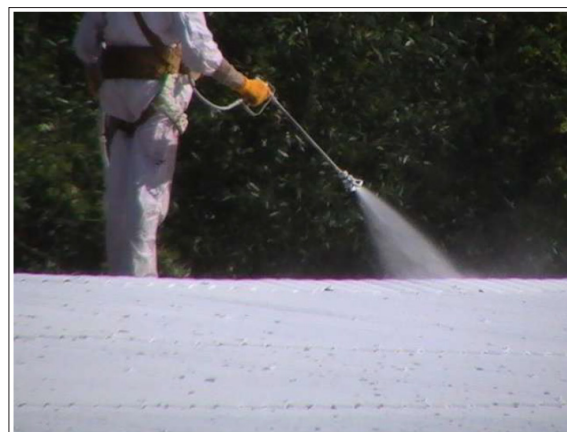
**Figure 28:** Fiber Fixing Polymer Application over Corrugated Roofing Plate, Prior to Deasbestos Removal. (author's Photograph)
